Bottom structure proposals to increase the thermal cycles resistance

Application to Ultra Clear Glass & Electric boosting applications

TC 11 meeting at SGRP - 2023-12-13

JP Meynckens (AGC Europe)

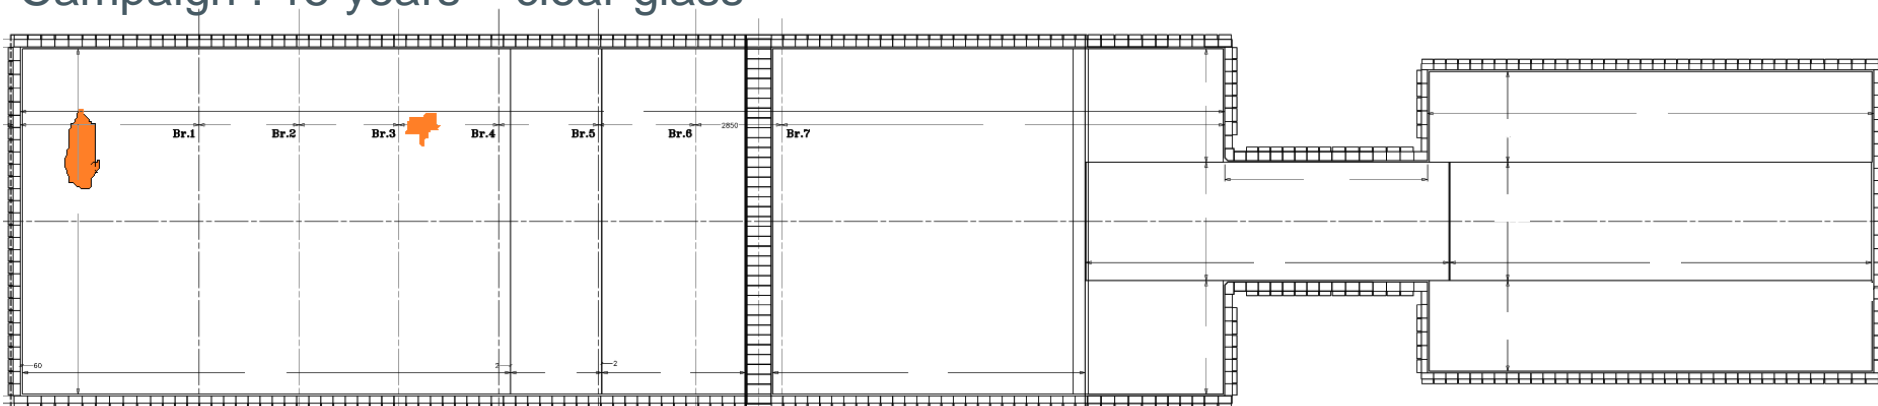
Furnace A

Few local glass infiltration indicated in orange
Homogenous wear -20mm)

Corrosion @ bubblers

Good state Homogeneous wear (-10mm)

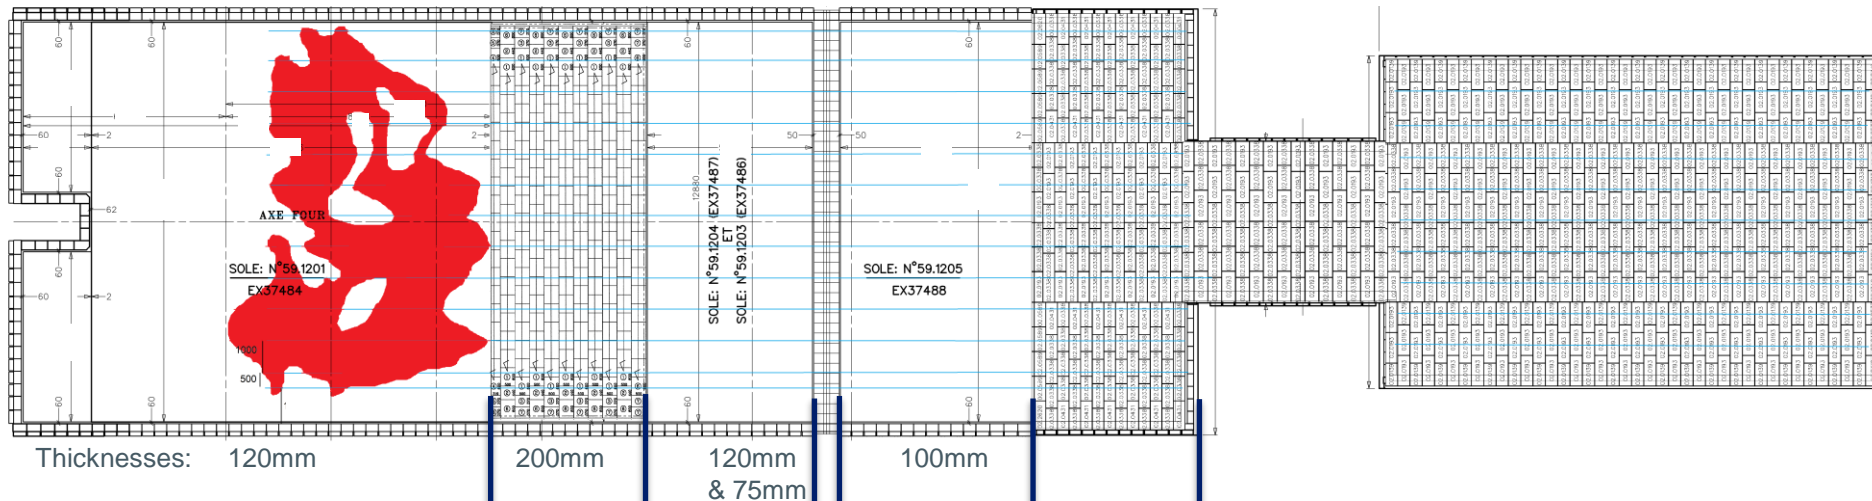
Furnaces B & C

Strong corrosion
& glass infiltration
Red area = AZS
paving
disappeared

Corrosion
@ bubblers
Good state
& no glass
infiltration
Sub pave
not
corroded

Moderate
corrosion

Al2O3
paving -
ridged

Good state
(salvaged area)

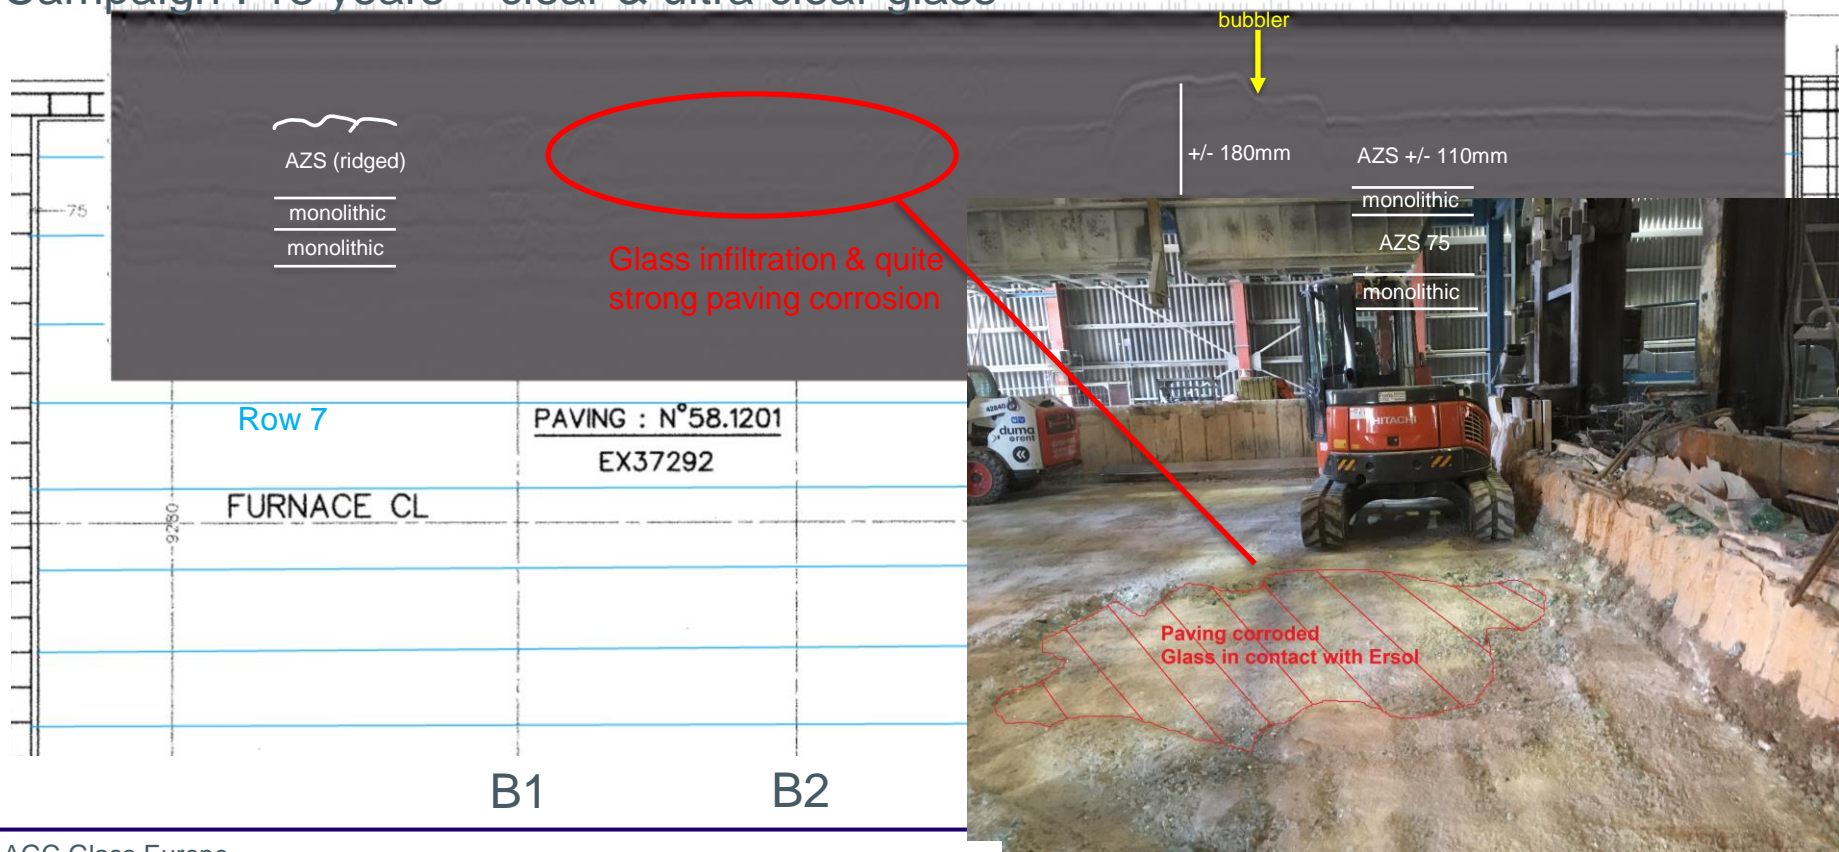
Furnace B - Melter overview (central line)

The GPR analyses of the furnaces B & C pavings after 18years campaign indicated a similar evolution

- 1) Strong corrosion of the pavings upstream the bubblers area.
- 2) The paving dedicated to the bubbler area is corroded only at the bubblers location.
- 3) The paving between the bubblers and the dam wall is not corroded. The sub paving is not touched by the glass.
- 4) The Al₂O₃ paving is ridged in the stagnant area.
- 5) The Al₂O₃ paving is not corroded in the neck and in the conditioning end

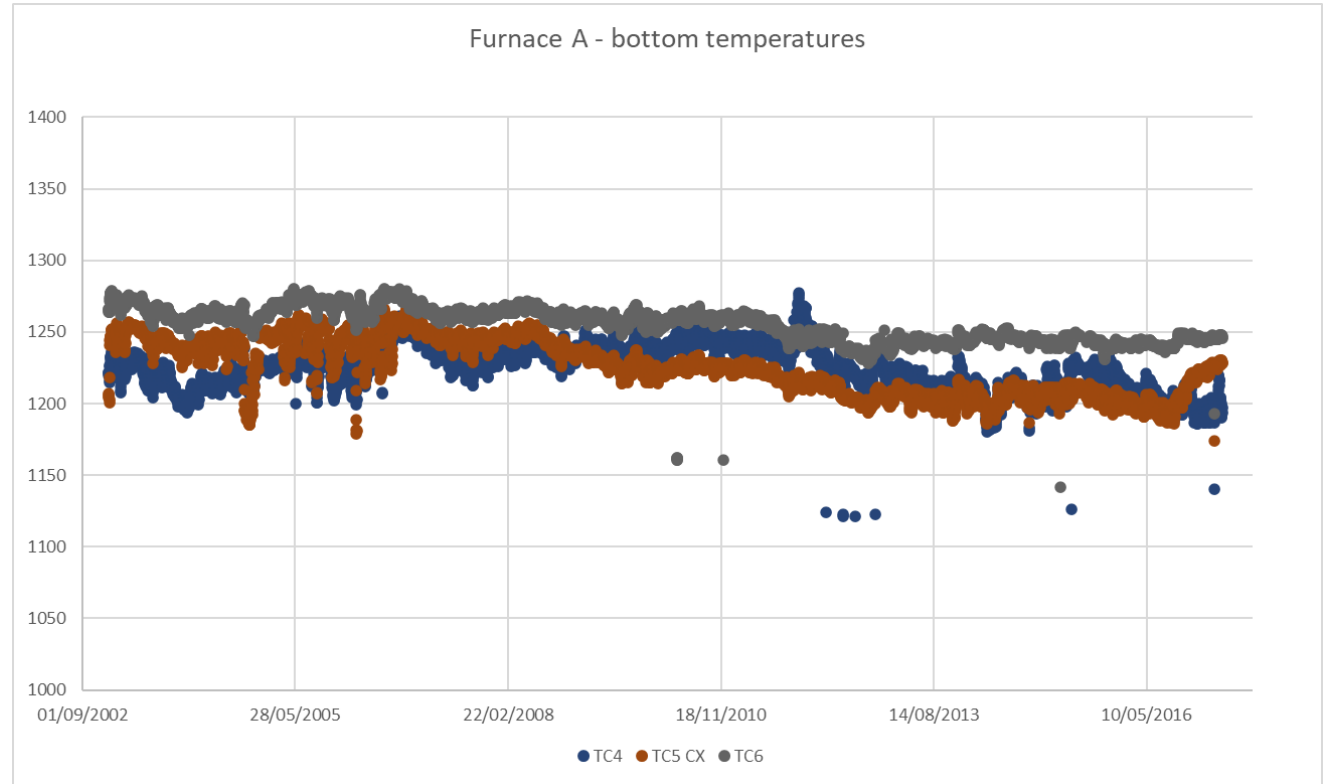
Discussions (2/5) – production history of furnace A

Furnace A – campaign 15 years:
No thermal cycles – stable pull – paving not corroded

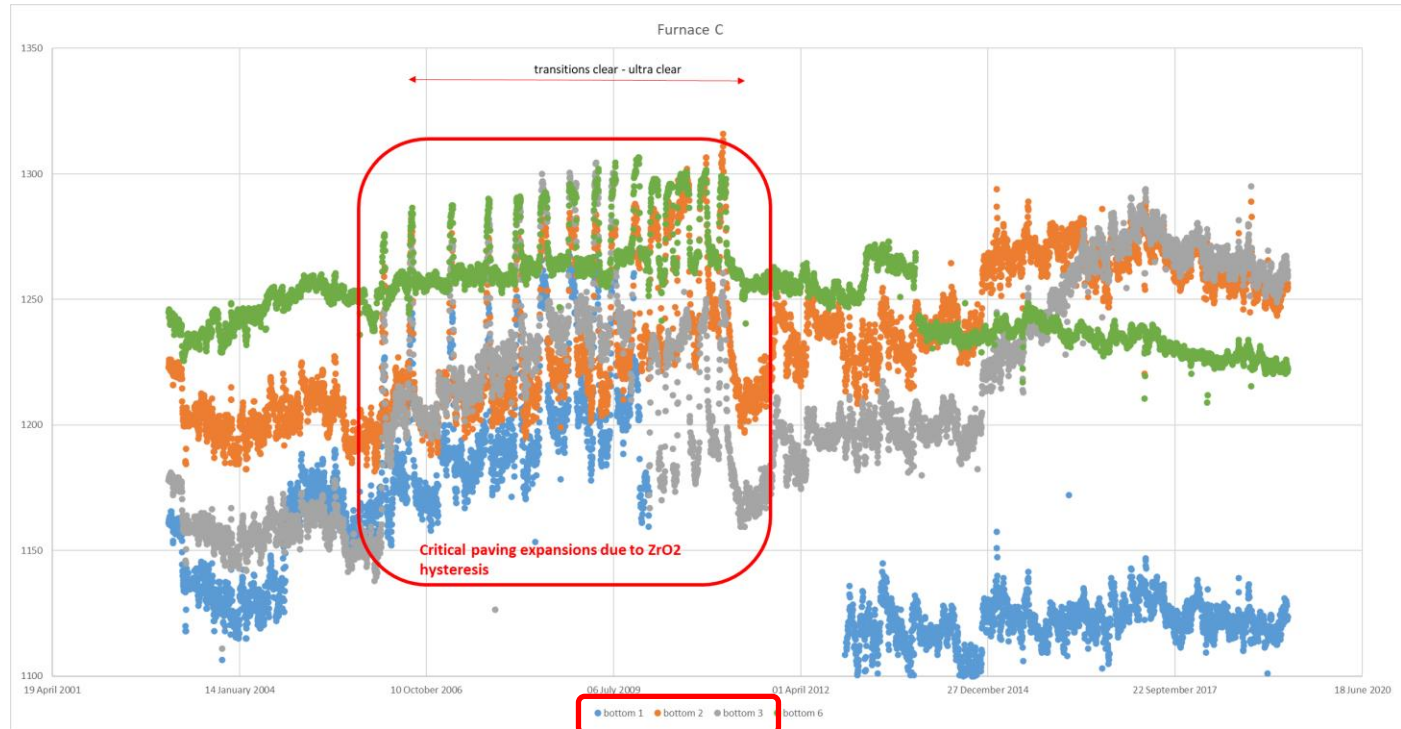
Discussions (3/5) – production history of furnace C

Furnaces B (similar to C) & C – campaigns 18 years:
Critical thermal cycles – pull changes – paving corroded

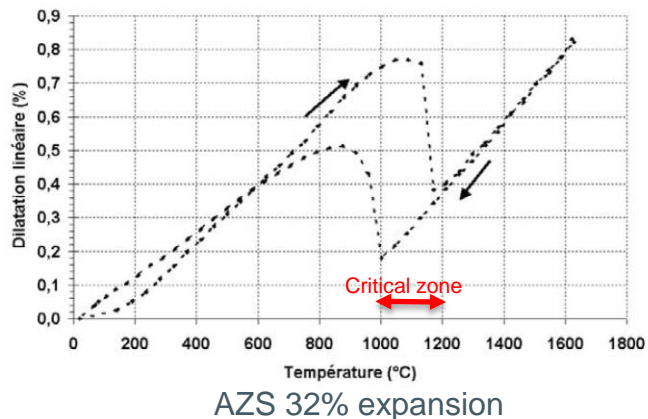
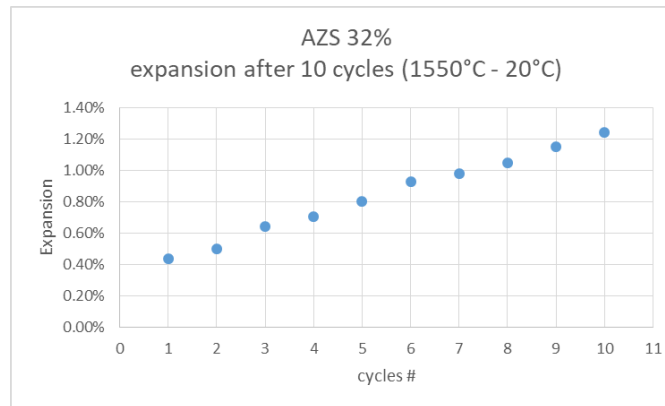
Discussions (4/5) – ZrO2 expansion & hysteresis

AZS 32% expansion during each cycle

Note: such expansion can be measured from exsudation Dunkl(*) tests

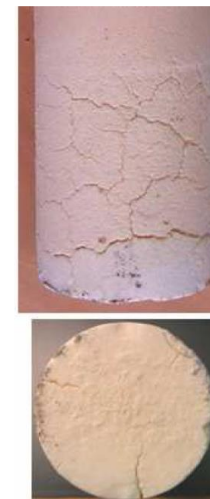
AZS 32% cracks induced by thermal cycles

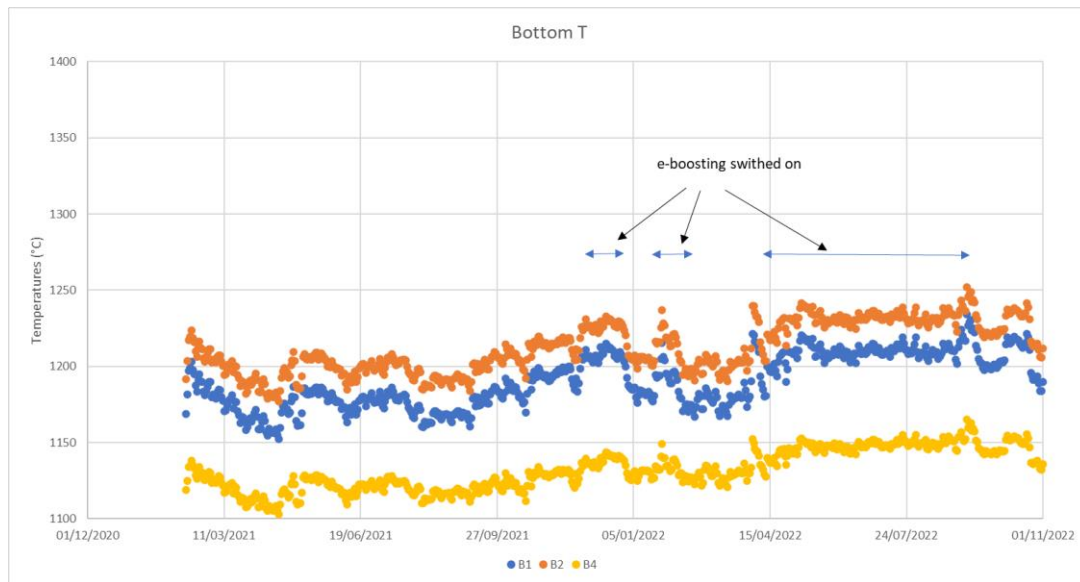
Electric boosting -> local overheating at electrodes and thermal cycling during on/off periods

Some thermal cycles are visible in the pavings due to the electric power variations and the critical cycles are observed on the pavings at B1/B2/B4. At present, these cycles are less sensitive than with UC glass transition but must be carefully followed

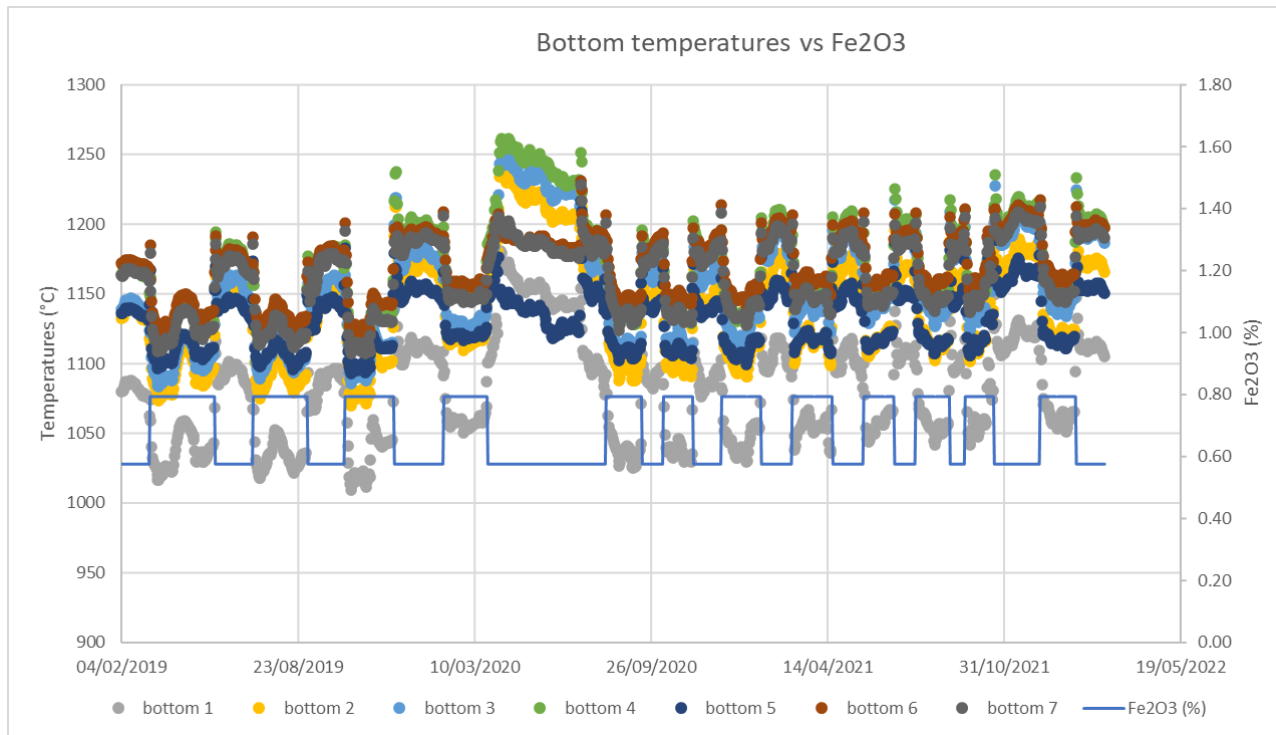
Glass transitions (% Fe2O3)

- 2 root causes leading to critical thermal cycles in the pavings are detected: the glass transitions UC-Clear and, at lower degree but still to be analysed, the power variations in case of electric boosting use & colour changes. To avoid the stresses in the paving induced by these thermal cycles, we recommend the following:

- 1) Measure the paving movements by using mechanical strain gauges against the paving (see drawing)
- 2) Use of paving “sliding” under the tank wall
- 3) Use the partially stabilised AZS paving (with Y2O3) at the critical areas in order to avoid the strong paving expansion at lower temperatures or evaluate alternative materials with linear expansion.
