Refractory behavior in case of glass melting process change – few examples

Dr. Rongxing Bei

October 21st, 2024

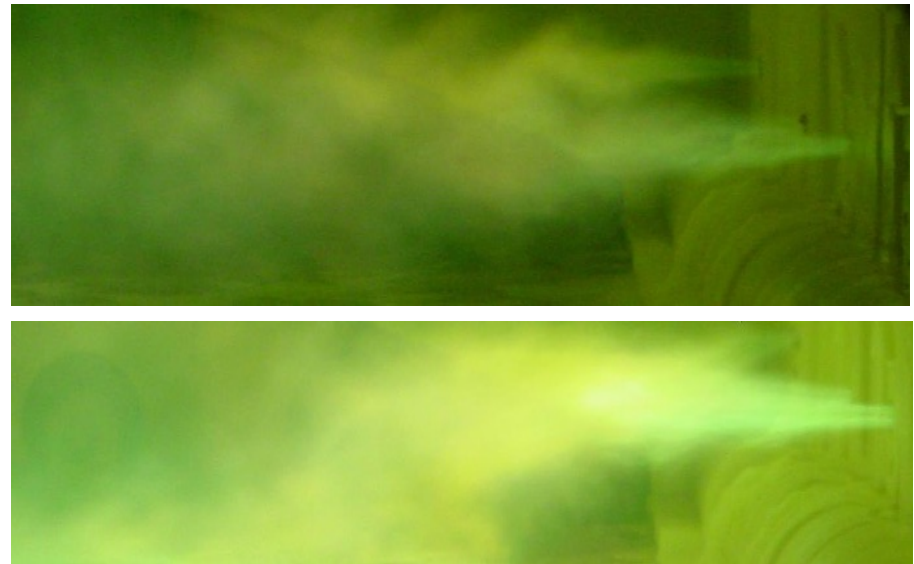
- One furnace uses oxyfuel firing
- The process change has caused decreasing the gas amount on few burners
- After a time of period the process changed back

- However the flame not straight any more (downwards directed)
- Consequence: more carryover, more Na-evaporation

- Looking for the reasons
- Problem solved after replacing the burner block
- The firing happened inside of the burner block during the period of low gas amount

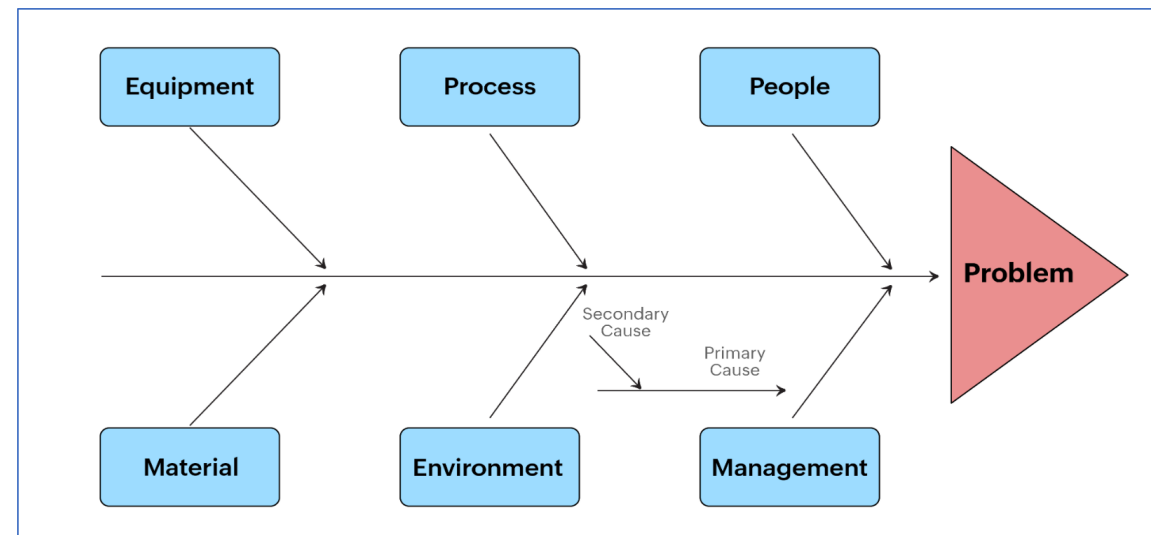
- The customer changed few furnace parameters: bubbling amount, burner setting...
- Foam formation become stronger
- Higher melting temperature needed
→ more corrosion on refractories
→ dripping on silica crown started
- Change back of the process parameter: no improvement reached

- According to Ishikawa diagram: impurity in one raw material could be the reason

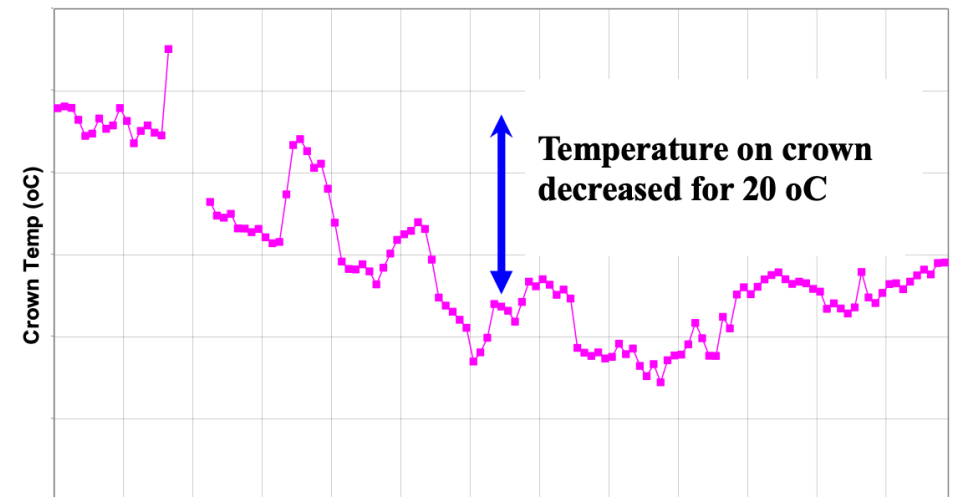
- The melting test in lab confirmed the „problem maker“ is the impurity of one raw material
- Use right raw material
- Foam become thinner

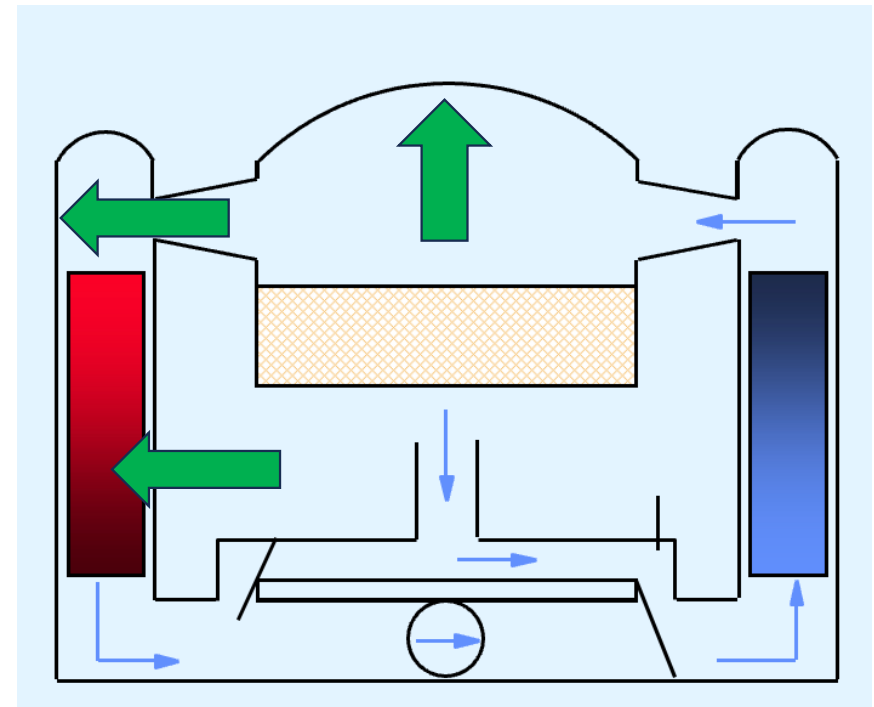
For one regenerative furnace, during a time period the melter temperature is lowered

- For regenerator chamber: the formation of nepheline on mullite wall and crown, peeling happens during coming back to higher temperature

- For regenerator checker: the condensation zone moved to higher position, these bricks are not foreseen resistant to sulfate attack. More corrosion

- For melter: temperature went down, more silica corrosion and dripping happened
