Radar testing of fused cast refractory

TC11 Meeting
Düsseldorf, 22.10.2018

Introduction

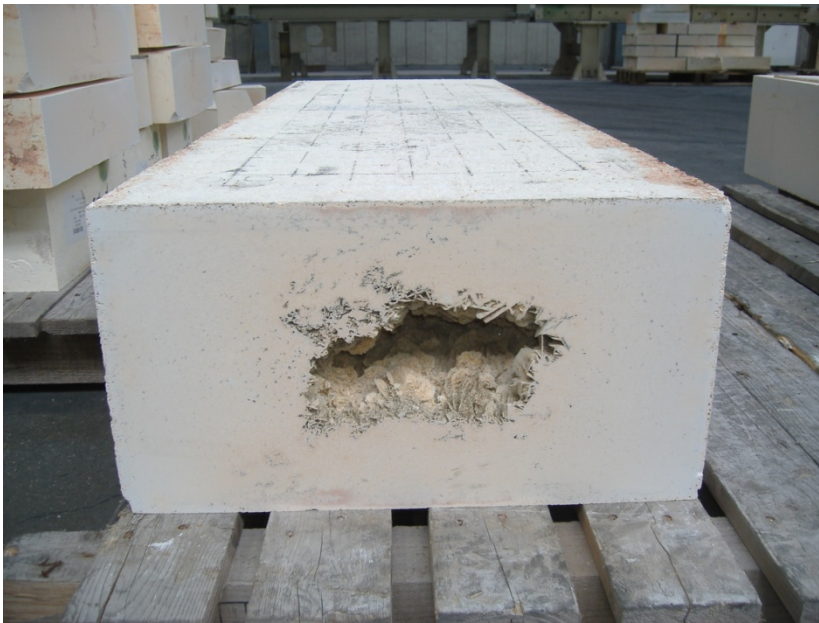
Cut face between the block and casting header. The residual cavity is visible, which is typical for CR. Cross section $250 \times 460 \text{ mm}^2$

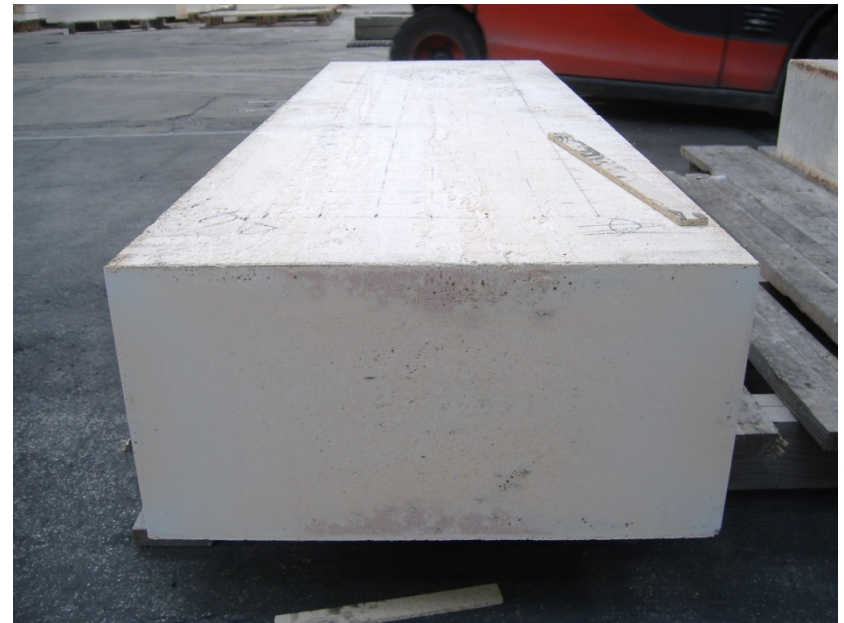
Cut face between the block and casting header of the FVB without any cavity. Cross section $250 \times 500 \text{ mm}^2$.

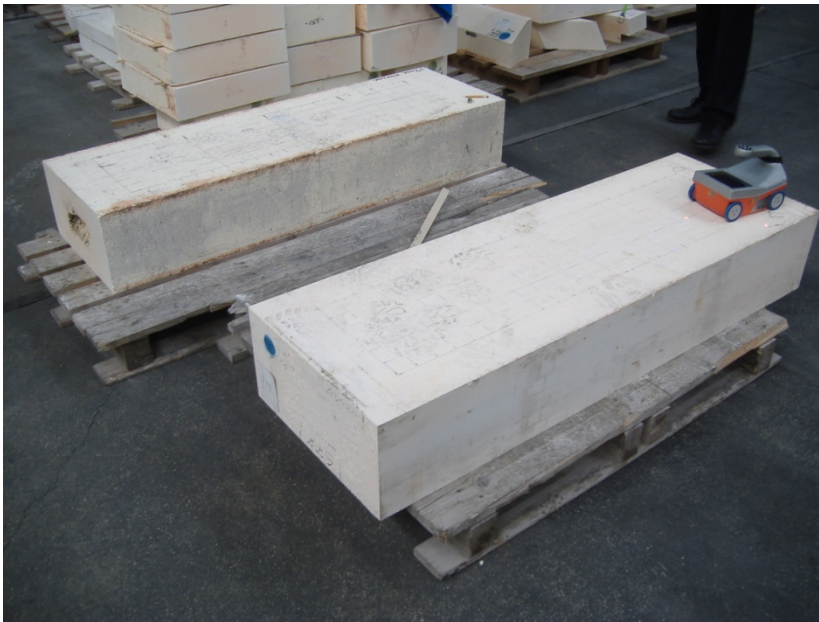
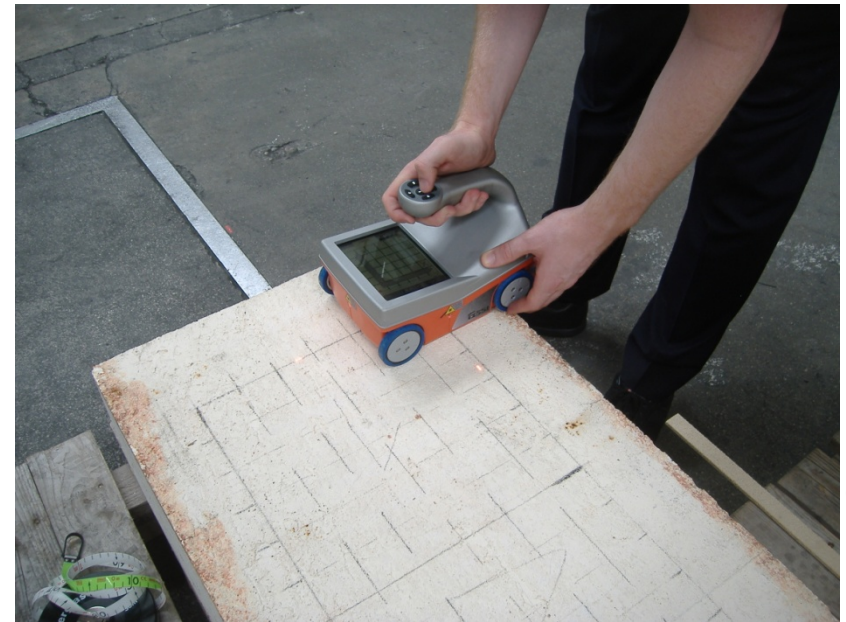
Blocks ready for testing (left). During testing the radar instrument is wheeled along the block surface (right).

Using the radar instrument a two-dimensional **2D** cross section along the centre line of a block is performed. It is reasonable to evaluate the block internal structure with only one single radar scan, with respect to the almost symmetrical structure of fused cast blocks in correlation to the symmetry plane.

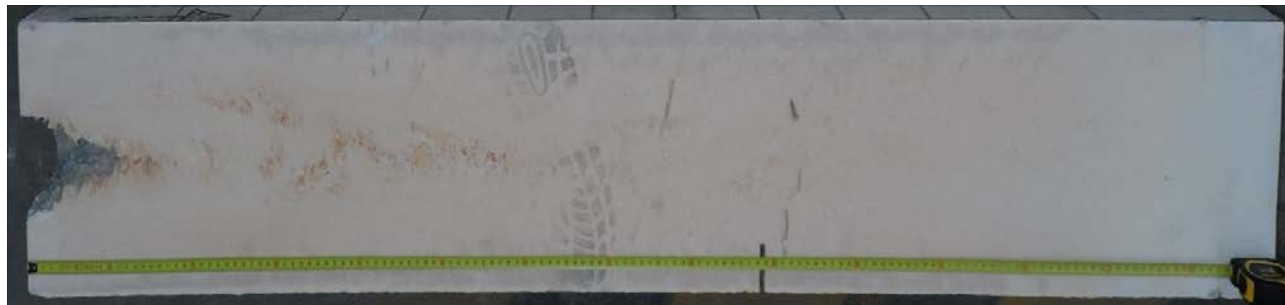
The referring original CR block with view on cutting face.

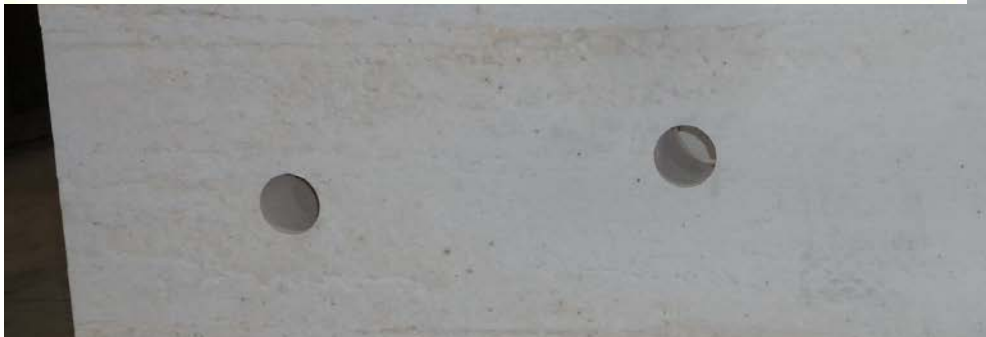
Example: Electrode block.

Interferences between radar reflections hinder the identification of the very left drill hole — which is doubtless visible in the picture below. This indicates, that data processing cannot always be avoided.

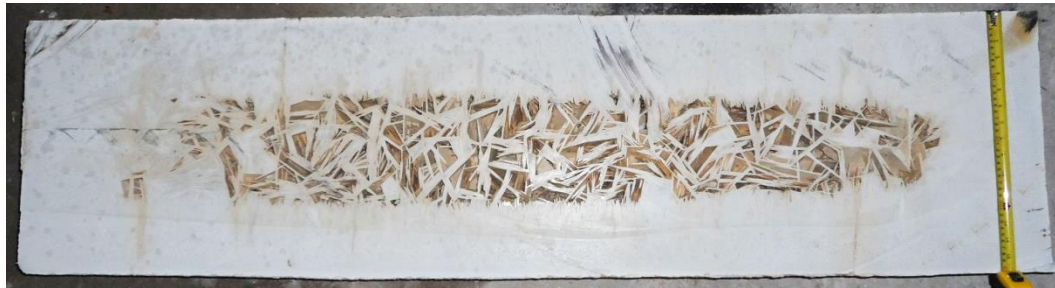
Horizontal cut regular cast block.
