Tin Bath Blocks & Assessment Studies

Melih Üstün

ŞİŞECAM SCIENCE & TECHNOLOGY CENTER

TC 11 – 19th of September 2022

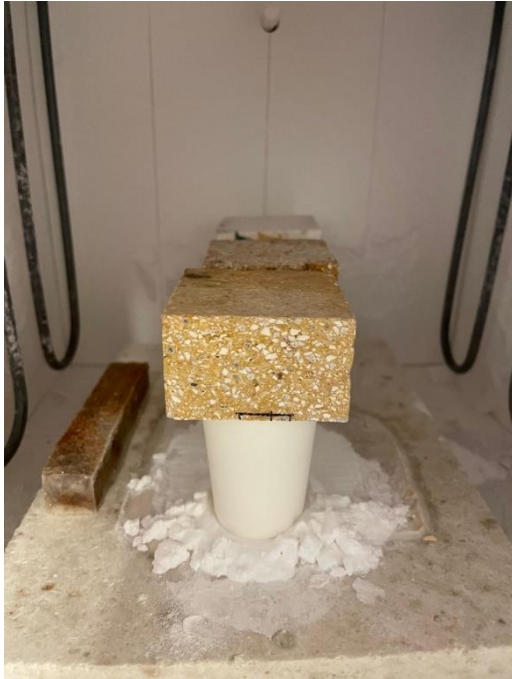
Alkaline penetration test set up

- Alkaline penetration test
- Ultrasonic measurement
- Hydrogen Diffusivity test
- Proof test
- Cold Crushing test

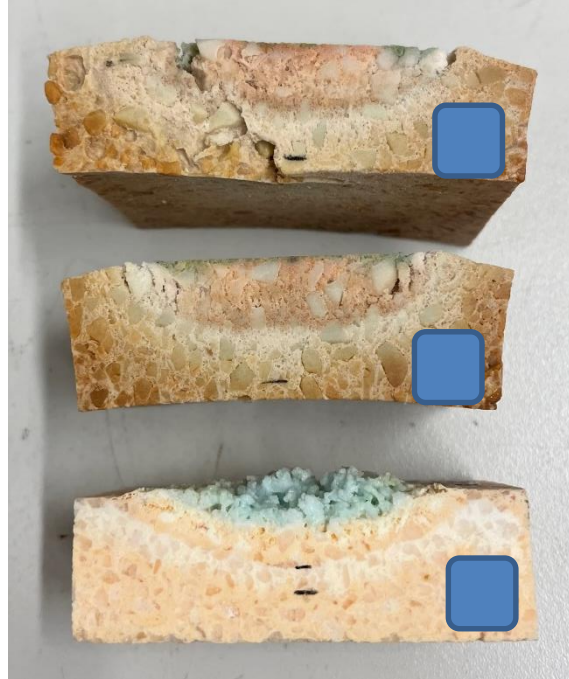
Cross-sectional view

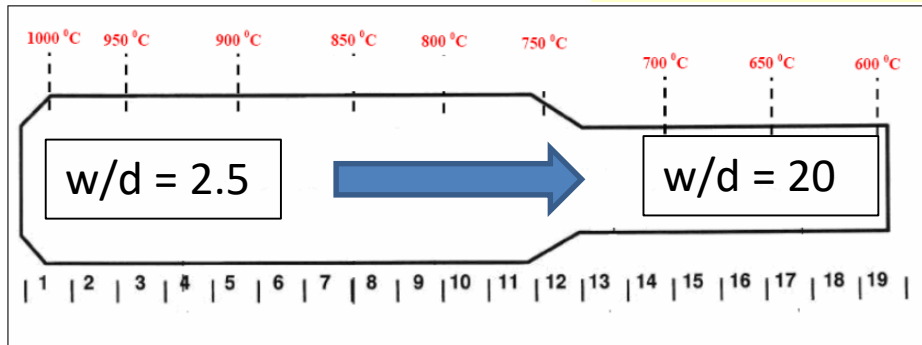
As the w/d ratio goes from 2.5 to 20;
 The origin of the bubbles approaches to the cold end.

w/d ratio defines where the open porosities come from

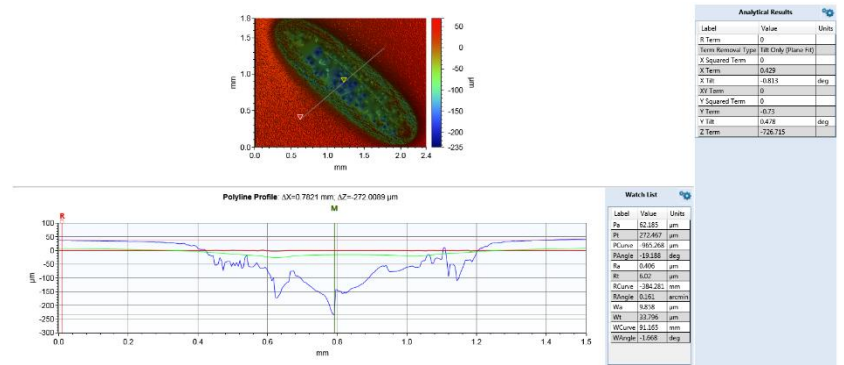
Confocal Systems for w & d measurements

• For collecting data from open bubbles (w/d ratio)

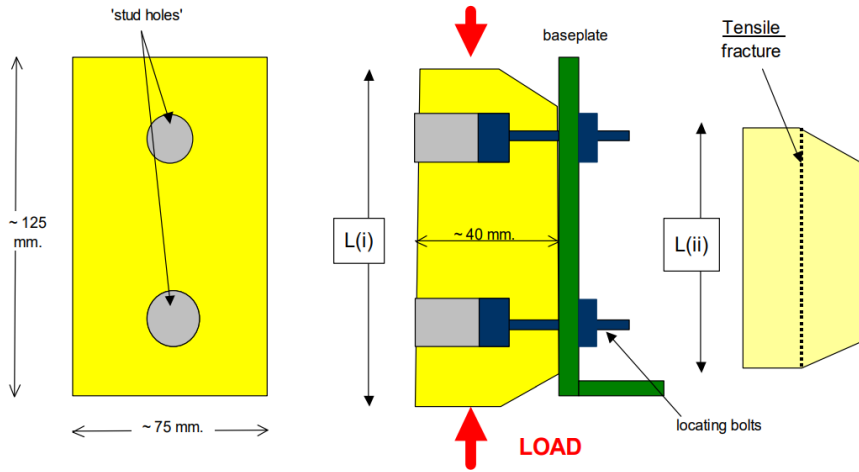
Proof Test

$$\% \text{ 'Strain to failure' } = (L(i) - L(ii)) \times 100 / L(i)$$

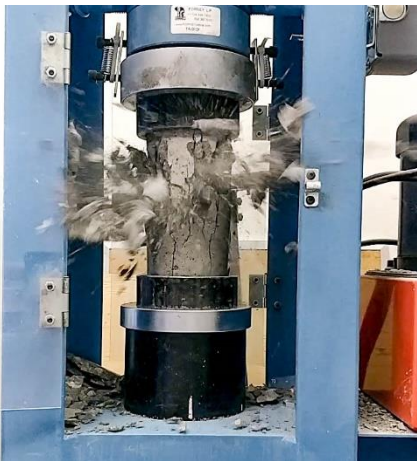
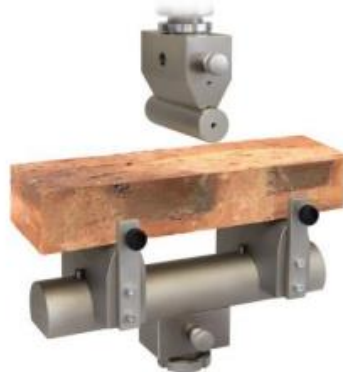
Cold Crushing Strength & Bending Tests

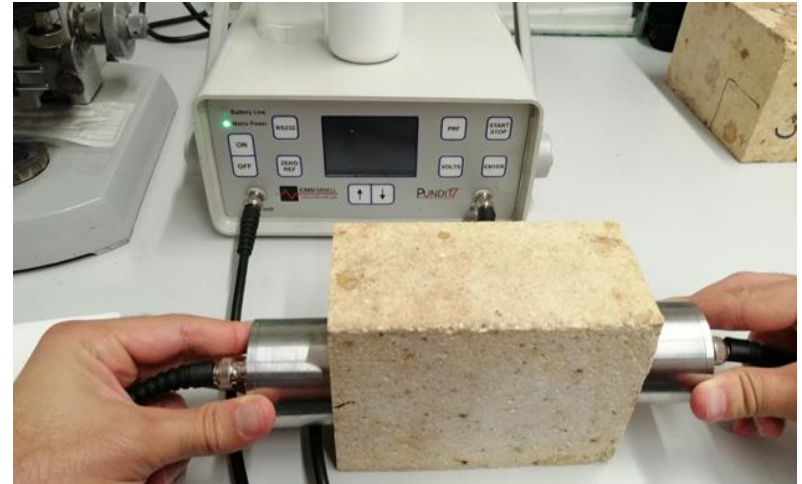
Ultrasonic Measurements
